How an issue with SAG mill dischargers became a nine-year-and-counting collaboration

With its two SAG mills suffering a range of performance issues, a polymetallic mine in Mexico invited us in to assess the situation.

Discharge head liners: SAG 38' x 22' 6"
Original steel liner design

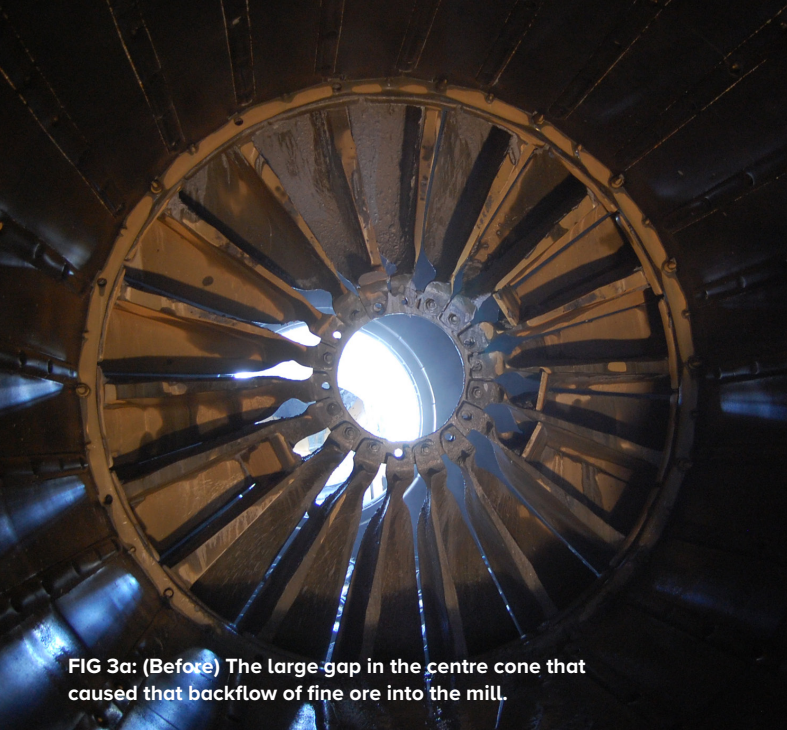
FIG 3a: (Before) The large-gap in the centre cone that caused that backflow of fine ore into the mill.

- Bolt breakage that led to pulp leakage from the discharger into the mill's hydraulic system, causing significant downtime. The broken bolts also needed to be replaced – a time-intensive activity. As a result, the mine was struggling to meet the mill's designed throughput.
- Excessive wear in the centre cone of the dischargers that left large gaps between the cones and resulted in the flow of fine material back into the mill, reducing grinding efficiency (Figures 3a-3c).

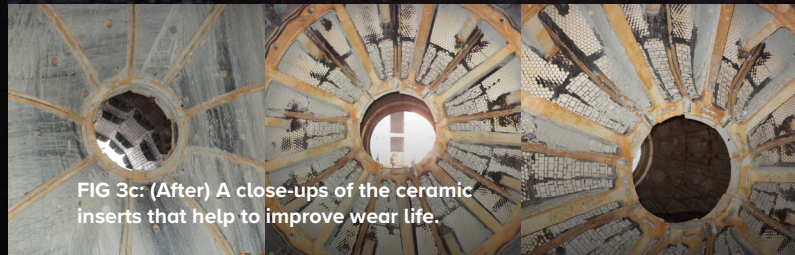
FIG 3c: (After) A close-ups of the ceramic inserts that help to improve wear life.

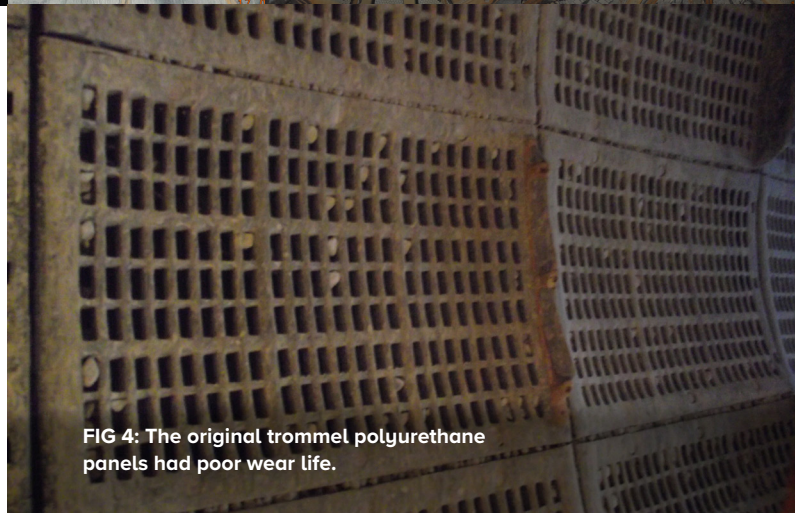
- The trommel panels were not lasting long enough and did not have enough open area (Figure 4).
- The water spray in the trommel was causing fine materials to stay in the trommel overflow, instead of being classified in the trommel (Figure 5).
- The trunnion adapter was unprotected, resulting in high levels of wear to the bolts. The trommel adapter was also wearing out (Figure 6).

FIG 4: The original trommel polyurethane panels had poor wear life.

For the trommel panels, we altered the thickness, improving the open area and DAM profile, using our special rubber lining to increase the wear life from 3 months to 5 months. Previous polyurethane panels had been attached with pins, but the new rubber panels use a rail system that allows much faster and safer installation during maintenance (Figure 9).

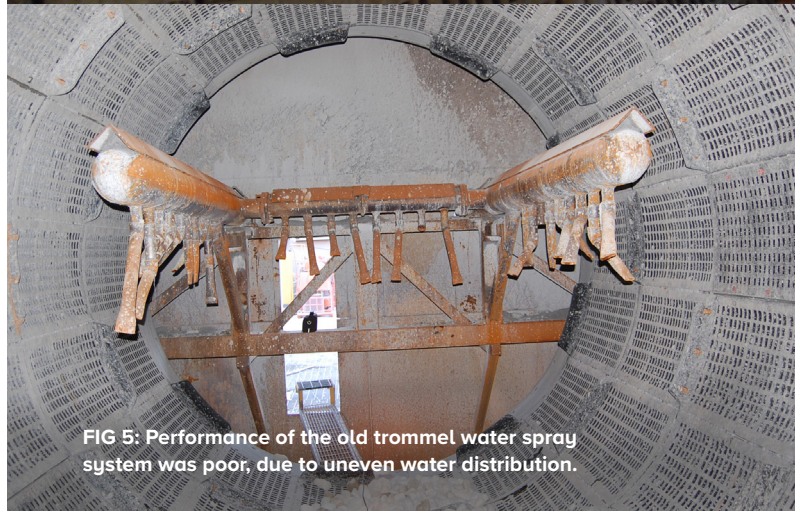
FIG 5: Performance of the old trommel water spray system was poor, due to uneven water distribution.

The trommel water system was also completely replaced with a system comprising four water tubes and polyurethane 'jumbo' nozzles. These provide better wear life and spray pattern, ensuring the fine material was classified through the trommel, rather than building-up in the trommel overflow, as it had been doing (Figure 10).

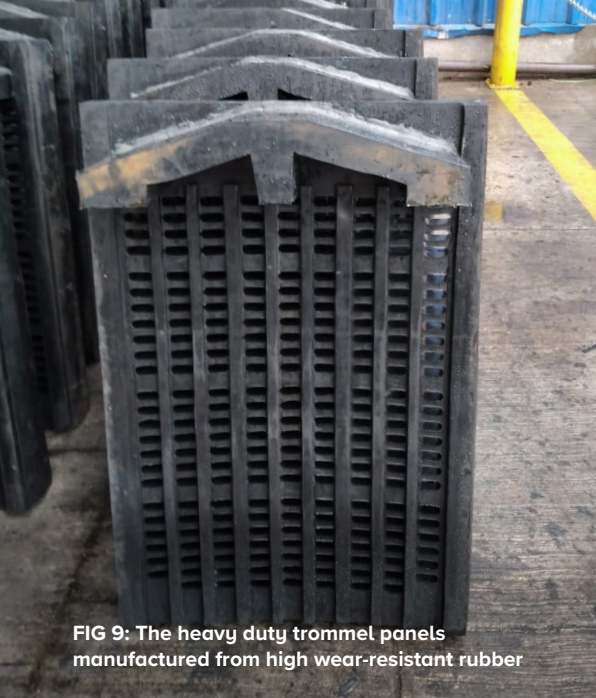
FIG 9: The heavy duty trommel panels manufactured from high wear-resistant rubber

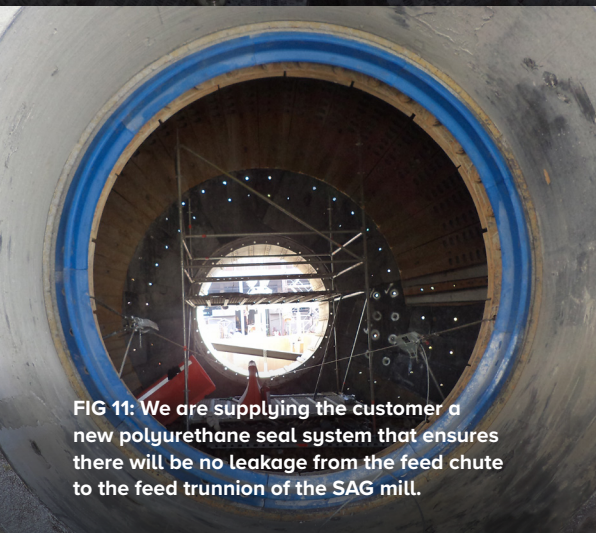
FIG 11: We are supplying the customer a new polyurethane seal system that ensures there will be no leakage from the feed chute to the feed trunnion of the SAG mill.

Trunnion liners were changed for a heavier-duty design with the aim of doubling wear life, compared to the original design. And we designed a new seal to avoid slurry leakage from the feed chute of the SAG and ball mill – with the new design installed in 2014 (Figure 11).
